An Archaeological Survey and Historic Buildings Assessment of the Crowley Lake Fish Camp, Crowley Lake, California

Prepared by Mary Farrell, Trans-Sierran Archaeological Research, with
Bauer Planning and Environmental Services, Inc., for
Mono County Community Development Department

Redacted version for Mitigated Negative Declaration
September 30, 2017

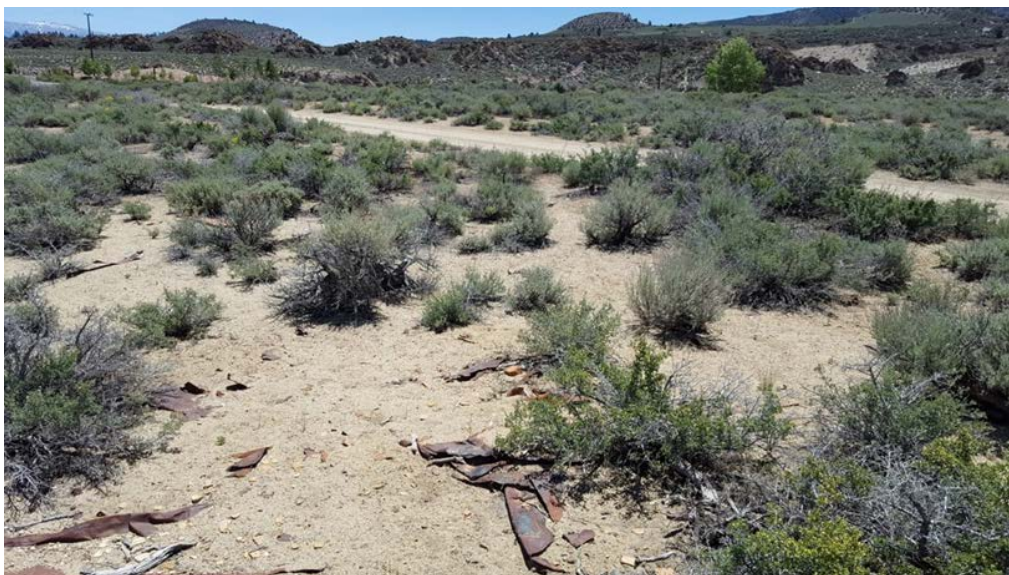
This trash scatter covers an area of about 160 by 175 feet. The artifacts include clay stove pipe, bed springs and frames, sheet metal, roofing, fragments of mason jars, ceramics, and bottles, bricks, window screen, water pipe, a wood-stove door, a door hinge, a strap hinge, a metal desk lamp shade, miscellaneous small hardware, and nails. With structural artifacts and furnishings as well as food storage and serving artifacts, the trash is more substantial than what would be expected for camping debris: it would seem more likely to be related to workers' housing, perhaps for dam construction. On the 1944 aerial photograph (see discussion below under CLFC-5), there appears to be a feature at about this location. The feature isn't clear enough to identify, but it is too substantial to be the trash dump, and may be a structure.

Figure 11, above. Overview of Historic Trash Scatter, Site CLFC-1. View to east.

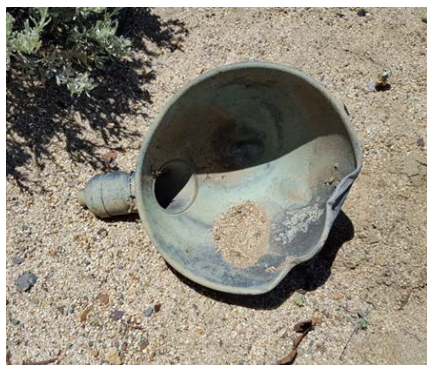
Figure 12, left. Metal shade for a desk lamp.

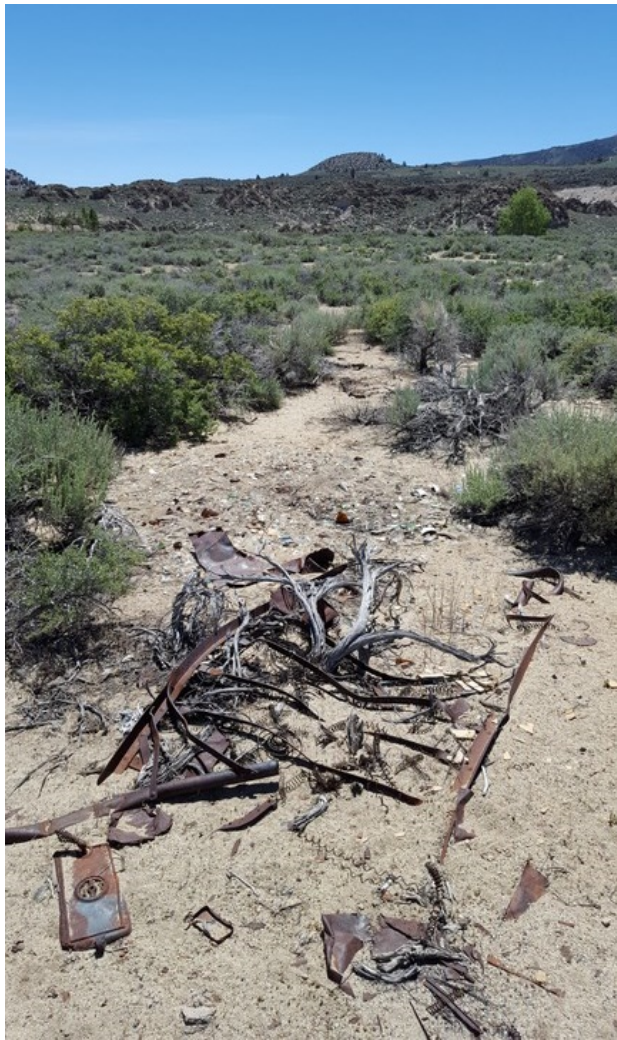
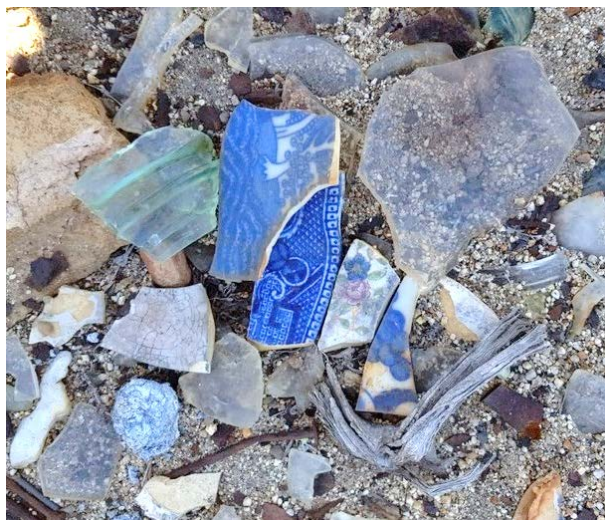
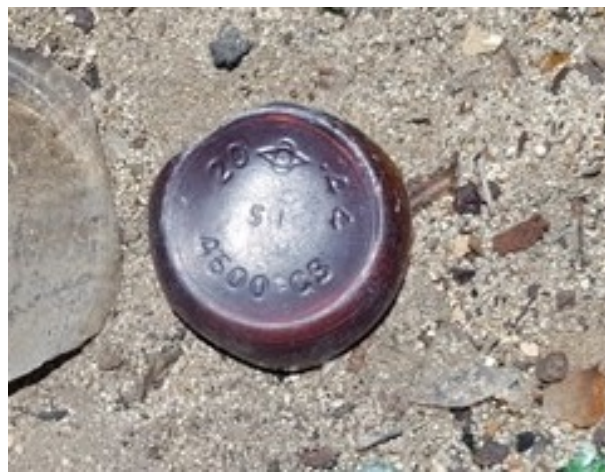
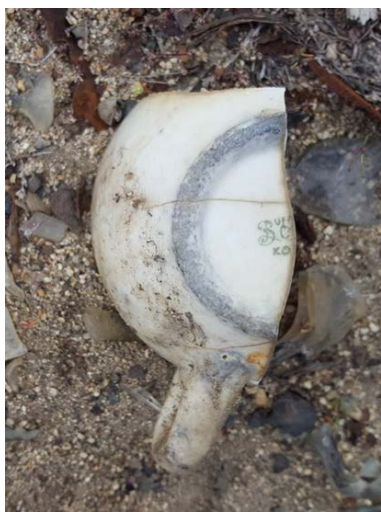
Figure 13. Upper left, bed frame and springs, stove door, and other trash. Upper right, a closeup of part of the trash scatter. Ceramic fragments include blue willow patterns, both hand-painted and transfer-print. Above, beer bottle base. The diamond O-I mark indicates manufacture by the Owens-Illinois Glass Company. The "20" to the left of the mark indicates it was made at the Oakland, CA, plant, and the "44" to the right indicates the year of manufacture, 1944. Left, fragment of "hotel ware" cup. The maker's mark on the base indicates it was made by the Buffalo China Company. This style of lettering was common between 1915 and the 1940s (Conroy 1999:57). The "Ko..." may indicate a particular pattern, but sometimes letters under the manufacturer's name identify the hotel or restaurant for whom the pottery was made (Lehner 1988).

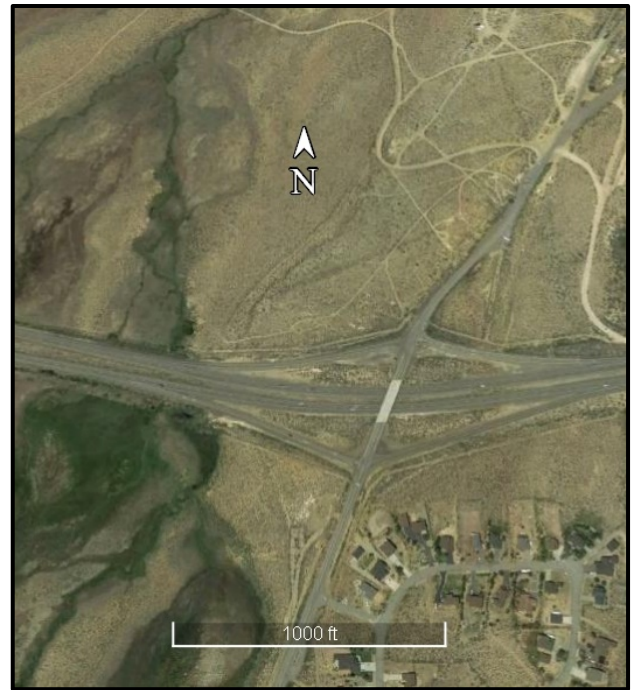
Figure 15, right. The alignment of the old road can still be discerned on the 2016 Google Earth image: it heads southwest from a current dirt road (in the photo, to the right of the north arrow), is crossed by the current U.S. Highway 395, and then heads south-southeast to join South Landing Road in the Crowley Lake residential area.

In the abandoned section, the roadbed is a flat area about 20 feet wide between two small berms, about 1 to 2 feet higher than the road surface. However, the road is unusual in that instead of following the natural ground surface, it appears to be atop a large berm, 10 to 20 feet above ground level on its southeast side, although the northwest edge of the road is not more than a foot or two above the adjacent ground surface. The construction, more substantial than what would be needed for fishing camp access, suggests the road was built as part of the reservoir construction.

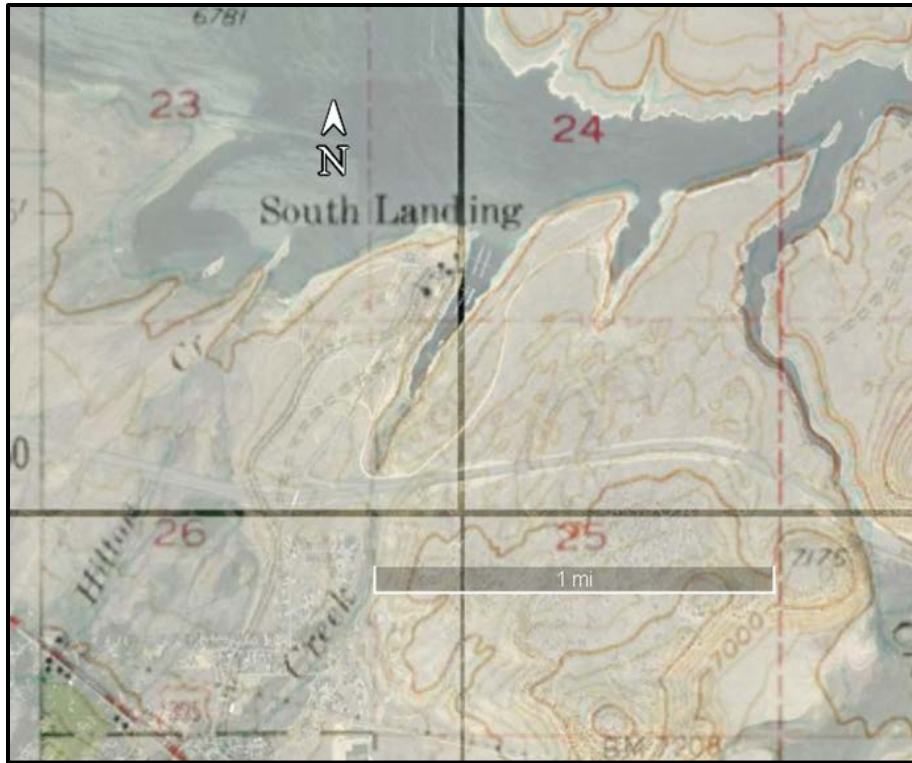
Figure 16. The original entry road, with the 1953 USGS topo map for Casa Diablo as an overlay on Google Earth.

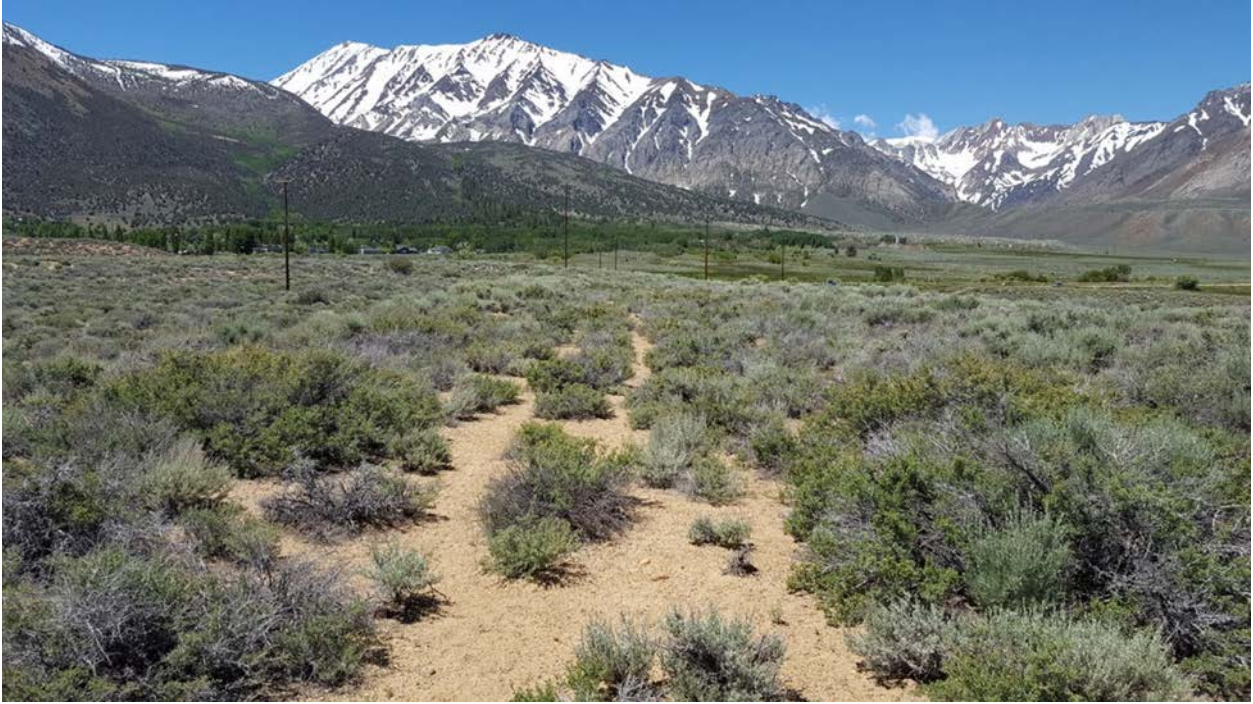
Figure 17. Historic site CLFC-5, abandoned road segment, view to southwest.

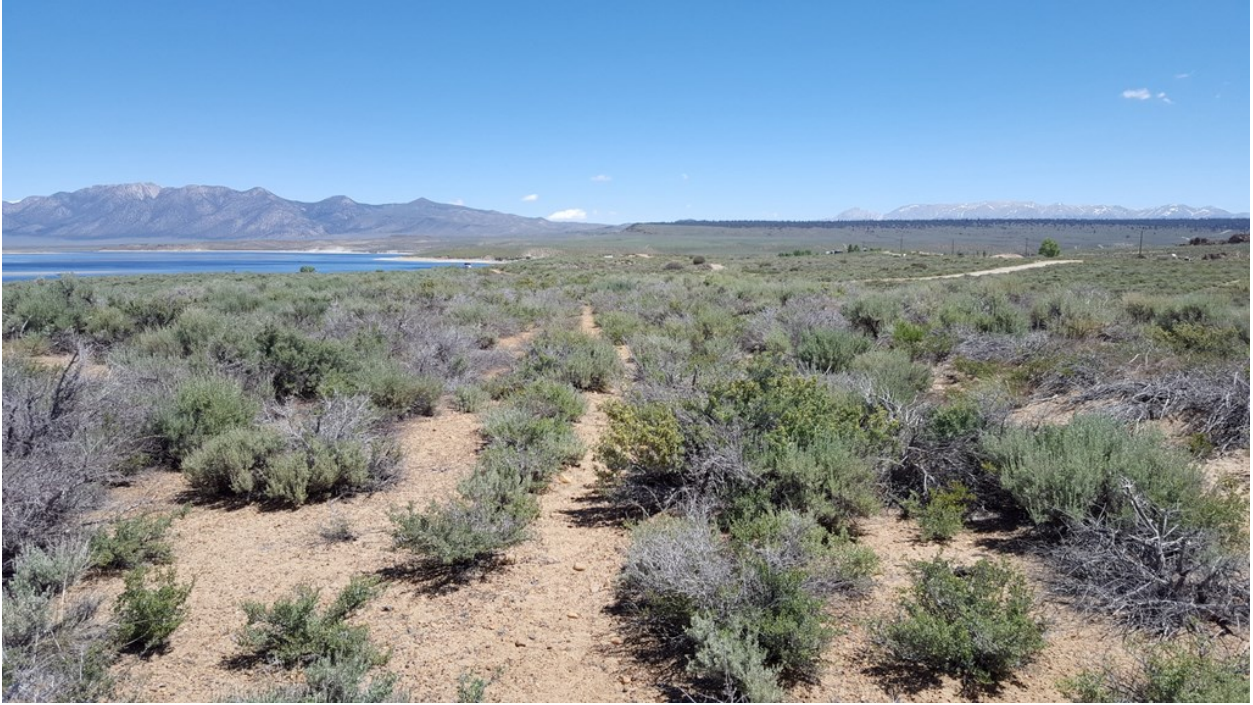
Figure 18. Historic Site CLFC-5, abandoned road segment, view to northeast.

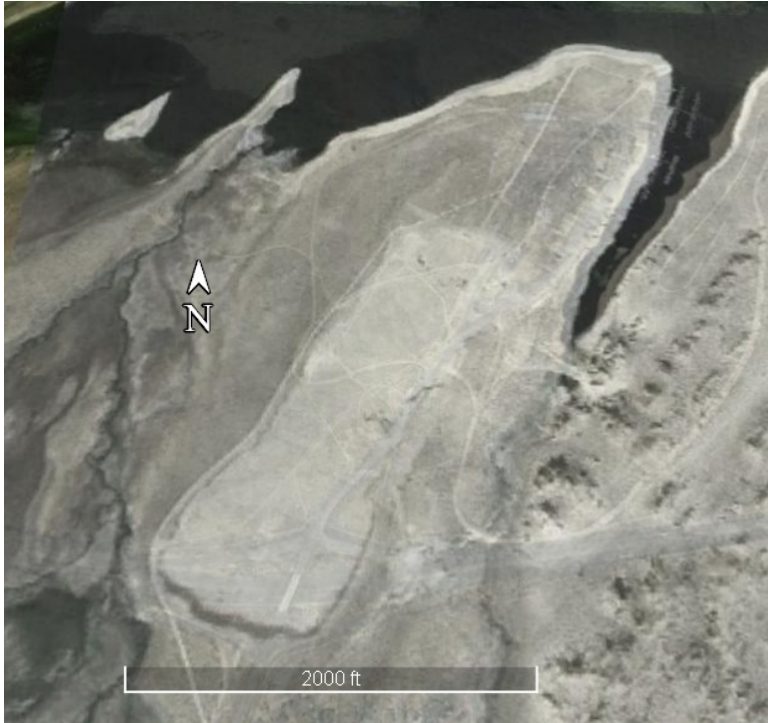
Figure 19. Portion of the 1944 aerial photograph. Note the clearing on the east edge of the road, indicated by large light-colored area. The shadow at the clearing's southern end indicates a cut deep enough to be discernible even at this resolution.

To test the validity of this idea, a digital image of a 1944 aerial photograph was obtained from the Map and Image Library of the University of California, Santa Barbara. This image shows a large cleared area, approximately 2,500 feet long by up to 1,000 feet wide, that stretches from the old road to the east-southeast. The area appears devoid of vegetation, and shadows on the clearing's southern edge suggest there was a deep cut there, now obliterated by the highway. Instead of being built atop a berm, the old main road was on the edge of a large excavated area. Some small features in the northern part of the clearing could be buildings or other structures, but the photo resolution isn't fine enough to tell for certain. Still, the 1944 aerial photograph does illustrate large-scale ground disturbance, most likely associated with the creation of the reservoir. The southern part of the Crowley Lake Fish Camp lease area may have been a borrow site for fill for dam construction.

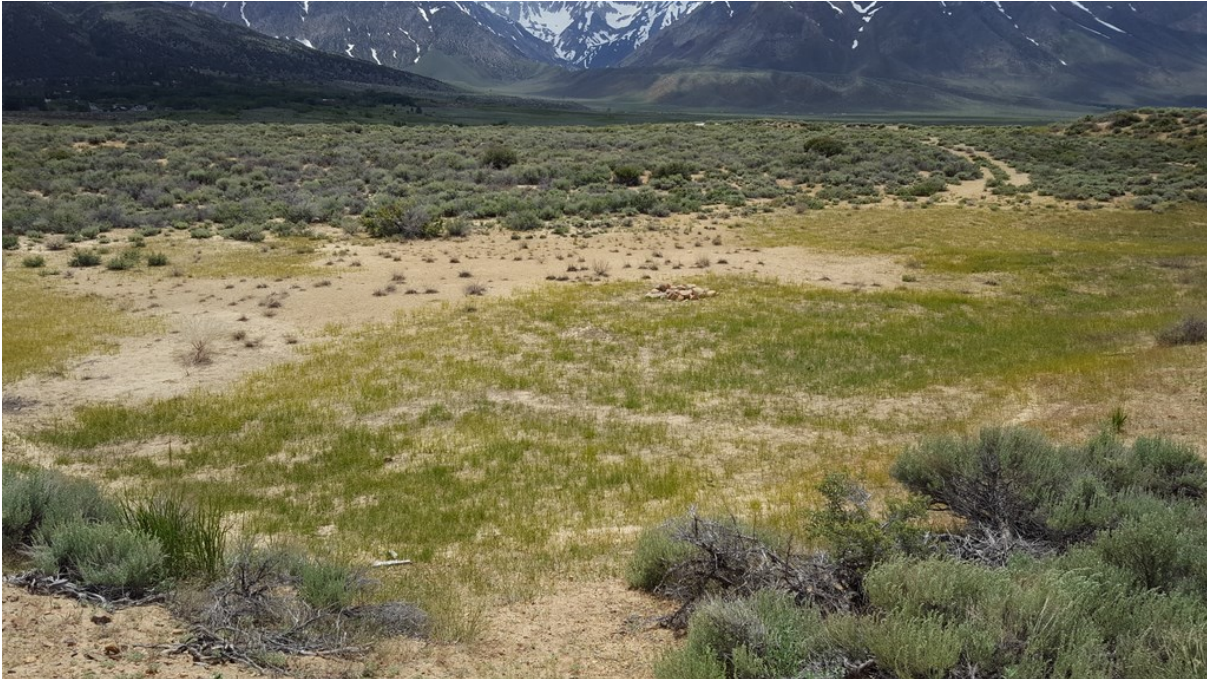
Figure 21. View south from what would have been the northern end of the cleared area shown in the 1944 aerial photo. The irregular terrain here and continuing south indicates that the cleared area was not completely leveled during dam construction activities.

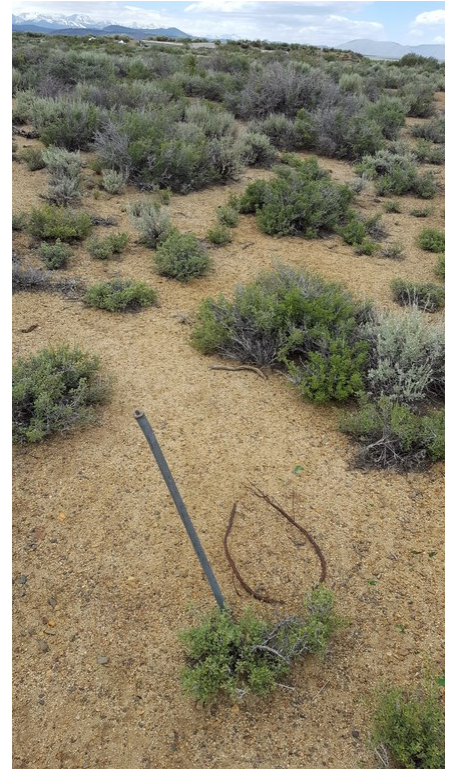
Figure 28. Isolate K, water pipe pounded into the ground and small piece of cable.

K	Water pipe pounded into the ground, ~30 inches visible. Small segment of cable.
L	Mound, about 15'x20'x2' high, with cable, pipe, other metal, white electrical porcelain, and applied-color label bottle
M	Mound, about 25' diameter and up to 5' high, with trash including big cable, pipe, heavy metal strapping, a meat can, a "Mission" brand soda bottle base, a metal lid, and glass
N	Homemade pail made from a can (sanitary seal, roller-opened) 6" tall by 5.5" diameter, with wire looped through holes punched in either side near the top
O	Weathered lumber (some with curved cuts) in the northeast and east edges of the green swale at the northern end of the cut visible on the 1944 aerial photo
P	Semi-buried rusted water pipe, about 3" OD, about 2' exposed
Q	Mound (5' tall, 40'x20') with trash: cable, corrugated roofing, other big pieces of sheet metal
R	Trash scatter, with pipe fragments, tin can, asbestos (?) pipe fragments, corrugated metal, heavy-duty machine part, sheet metal with nails

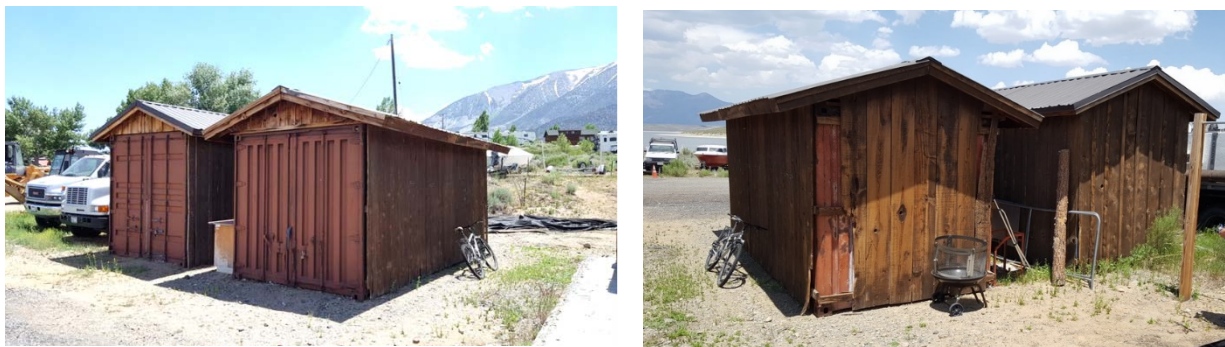
In addition, two other wooden structures with wooden siding are located near the Boat and Marine Building. Each serves as a shade or cover for a metal shipping container used as a storage unit, and measures approximately 20 feet long by 8¼ feet wide, and about 8 feet high to the eaves. The vertical wood siding is composed of 1-by-12-inch boards which have the appearance of old wood. However, the tight build around the storage units and the shallow-pitched roofs with new metal sheathing indicate that the structures were custom-fit to the storage units, using wood recycled from other structures. Crowley Lake Fish Camp personnel consider the storage units to be temporary, movable storage. Although the recycled boards are likely more than 50 years old, the structures themselves are not, and they are not eligible for the California Register.

Figure 31. Metal shipping containers within old-wood shelters. Left: front, view toward southeast. Right, back, view toward northeast. Note how tightly the covering sheds fit the containers.

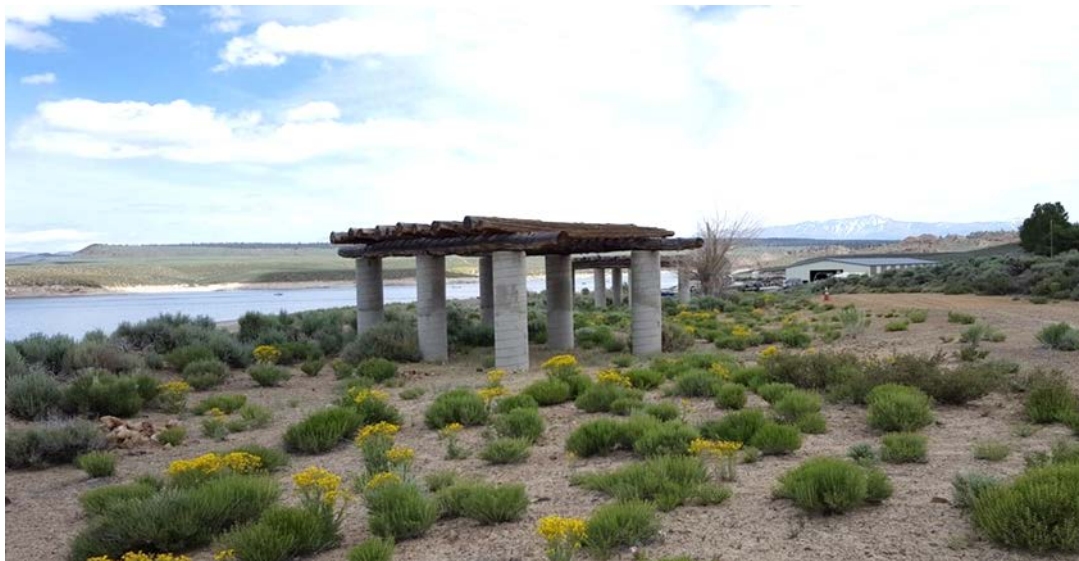
Two ramadas are located about 200 feet south of the lake shoreline, and about 300 feet and 400 feet west of the Boat and Marine Building. Each is constructed of six pillars of concrete formed in tubes, and a roof of peeled but unshaped logs. In plan, they measure 22 feet by almost 13 feet. Each pillar is 24 inches in diameter and extends approximately 7½ feet high, giving the ramadas a massive and somewhat industrial appearance. Logs of various sizes, up to 16 inches in diameter, form the roof. No evidence of recent use was noted.

Figure 32. Ramadas, view toward northeast.

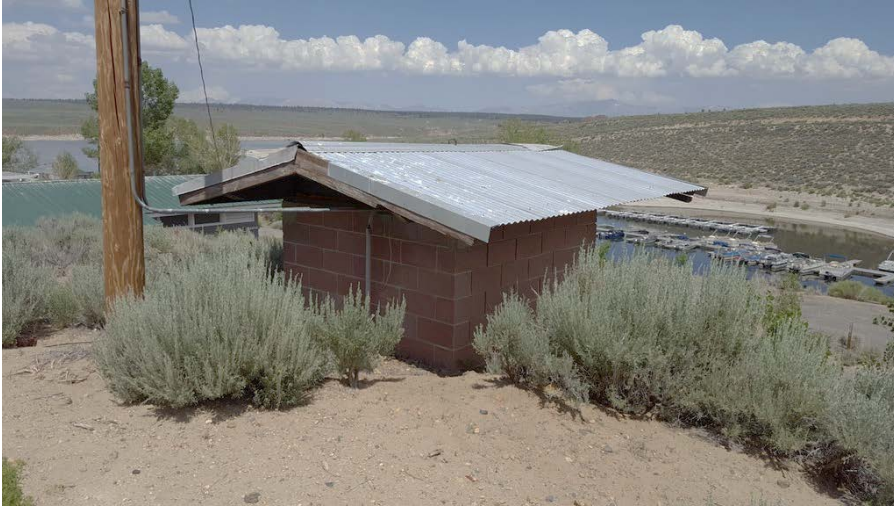
The well house, of concrete block, measures 7 feet 4 inches in plan, with an overhanging shallow gable roof framed in wood and covered in corrugated metal. The door, on the downhill side, is plywood.

Figure 33. Well House, view toward northeast.

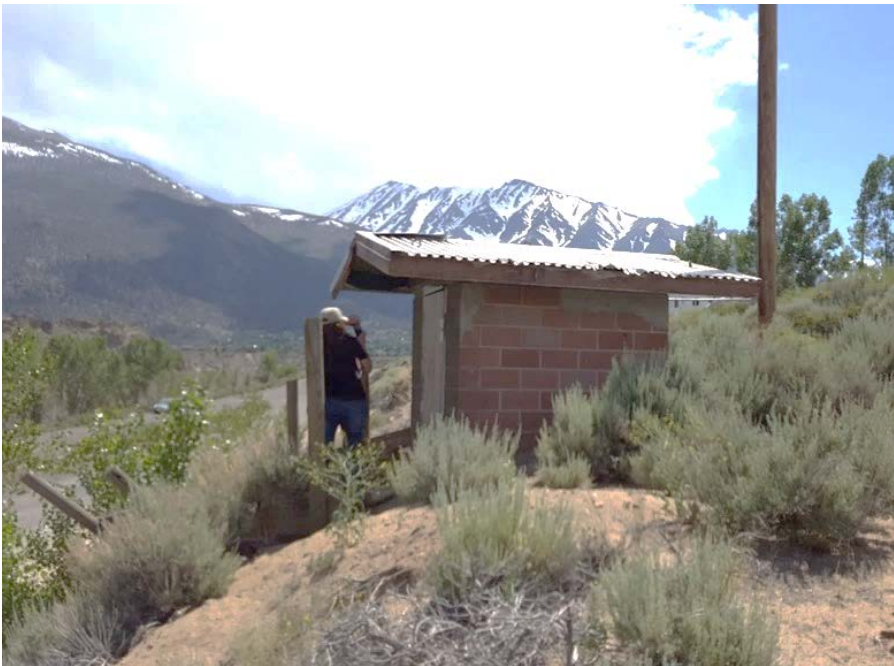
Figure 34. Well House, view toward south.

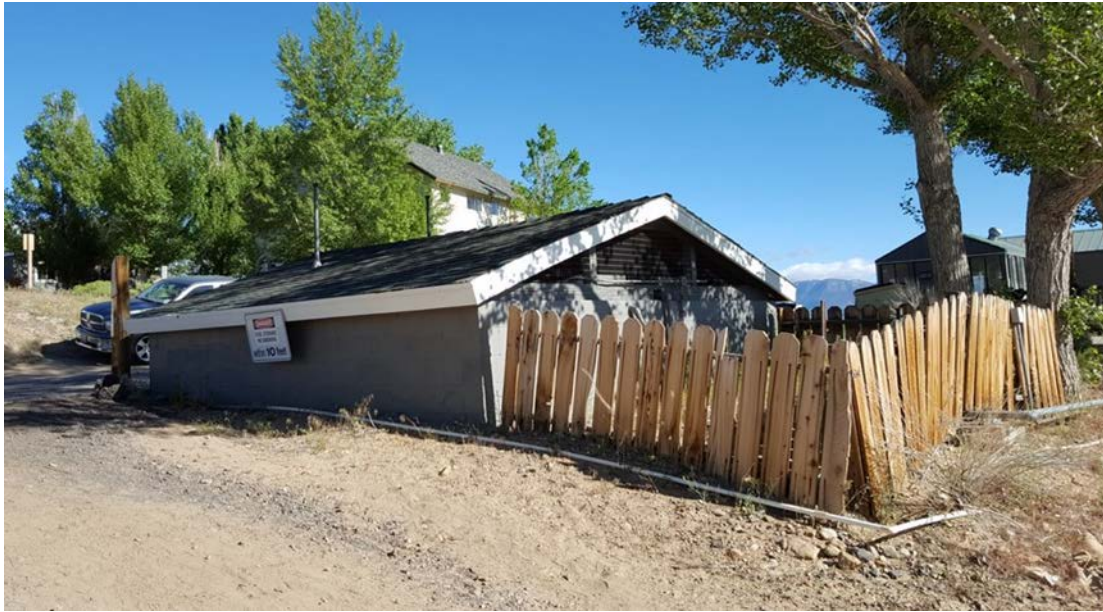
The fuel facility, measuring 16 feet by 15¼ feet in plan, is a partially buried concrete block building with an overhanging gable roof. The roof peak is 5½ feet above ground level in the front, and more in the back, on the downslope side. The shallow-pitch gable roof is covered in asphalt shingles. The entryway is a wood frame door, measuring 4 feet high and 2½ feet wide, with hardware screen, and there are vents in both gable ends.

Figure 35. Fuel Facility, toward northwest.

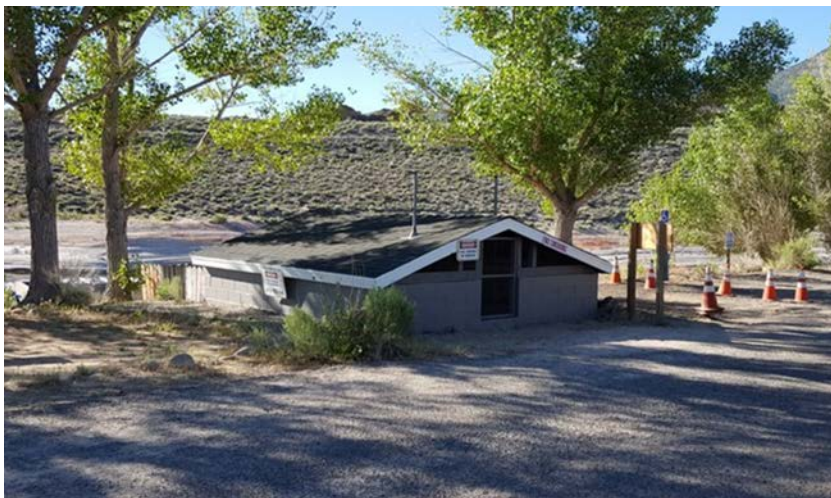
Figure 36. Fuel Facility, view toward southeast.

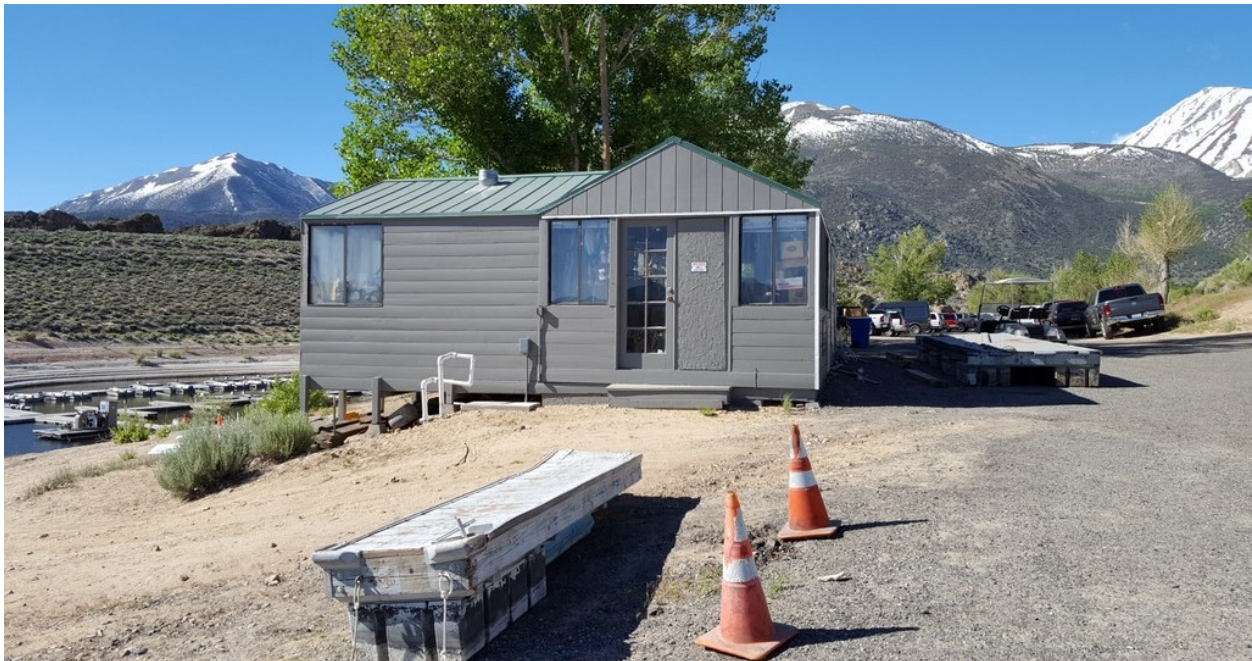
In the Mitigated Negative Declaration, the Boathouse/Storage building is described as a wood-framed one-story building on wood piers, with 588 square feet of interior space and a 140-square-foot deck. It is L-shaped in plan. Overall size is approximately 32 feet by 24 feet, with the north-south section 32 feet by 12 feet, and the east-west “wing” approximately 12 feet by 16 feet. The cross-gable shallow-pitched roof is covered in standing-seam metal roofing. Siding is horizontal tongue-in-groove boards, each 7 inches wide total, with 6½ inches exposed. Windows are aluminum sliders; doors include a multi-pane glass door and flush doors with a plywood veneer face. The wooden deck is about 12 feet by 12 feet, exterior dimensions, with a railing on three sides. Concrete steps lead to the back door. Although the windows, deck, roofing, and doors are new, the tongue-in-groove wood siding and the post-and-pier foundation could be characteristic of a 1950s or older building.

Figure 37. Boathouse/Storage Building, view toward south.

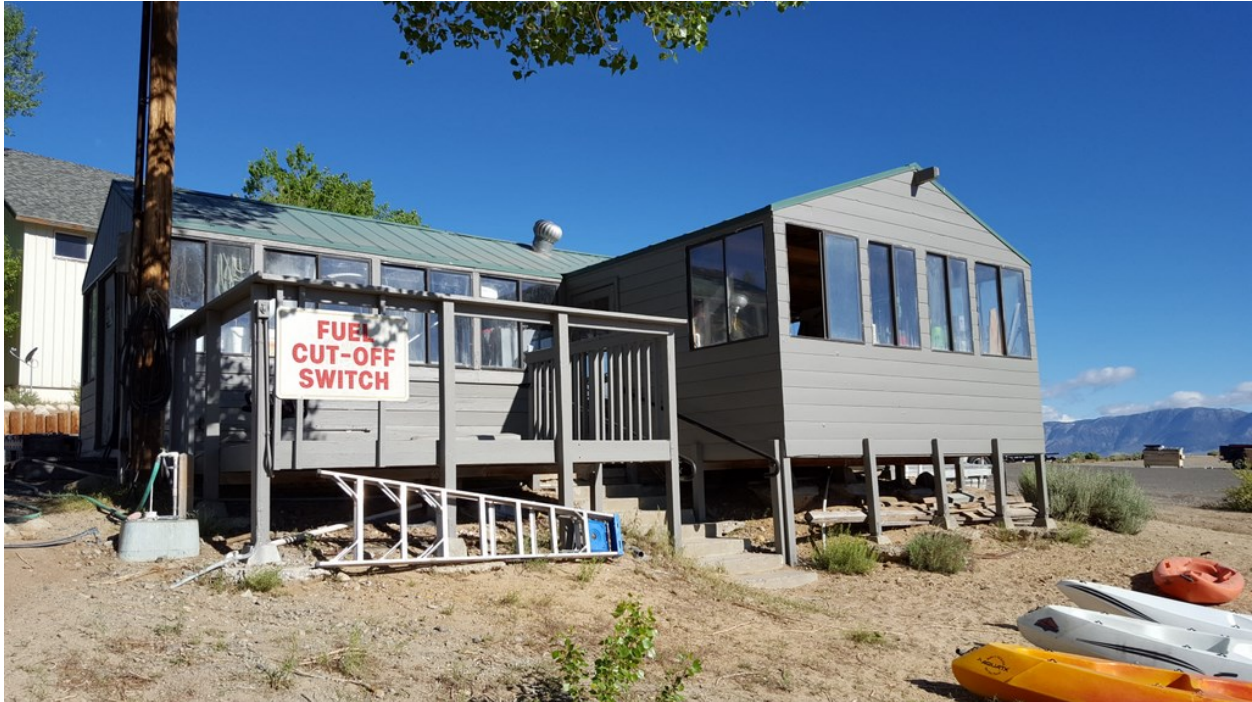
Figure 38. Boathouse/Storage Building, view toward northwest.

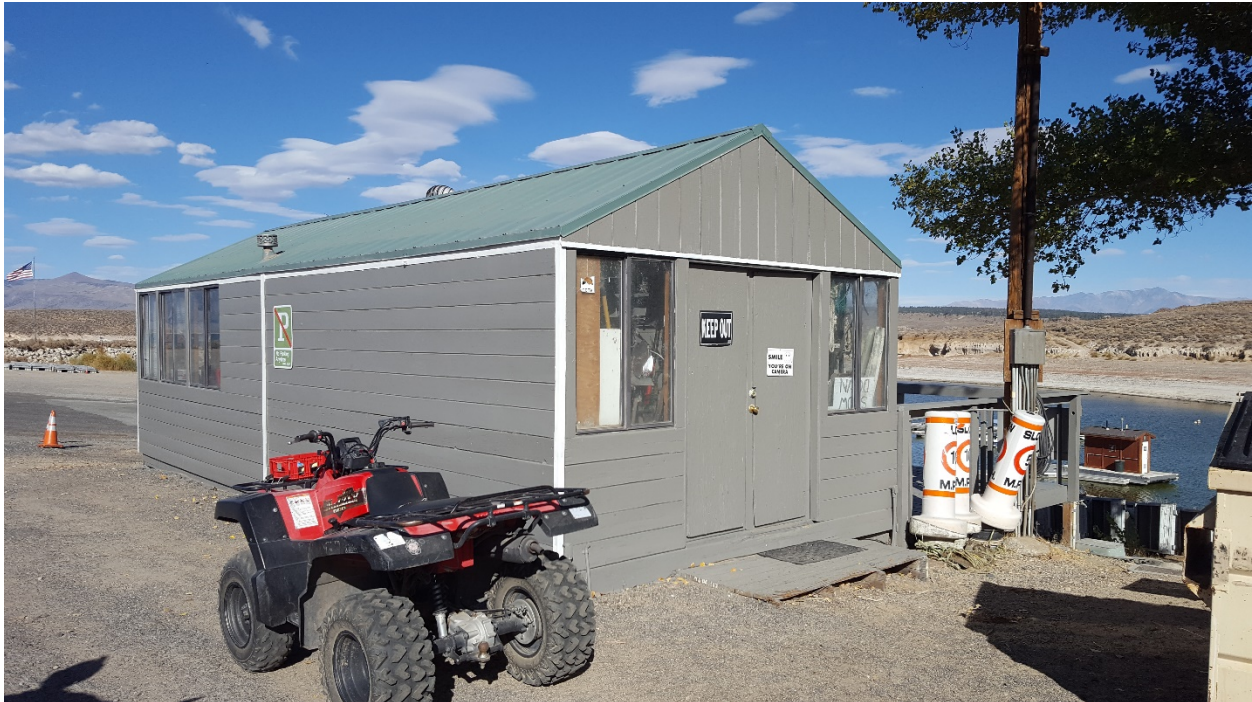
Figure 39. Boathouse/Storage Building, view toward northeast.

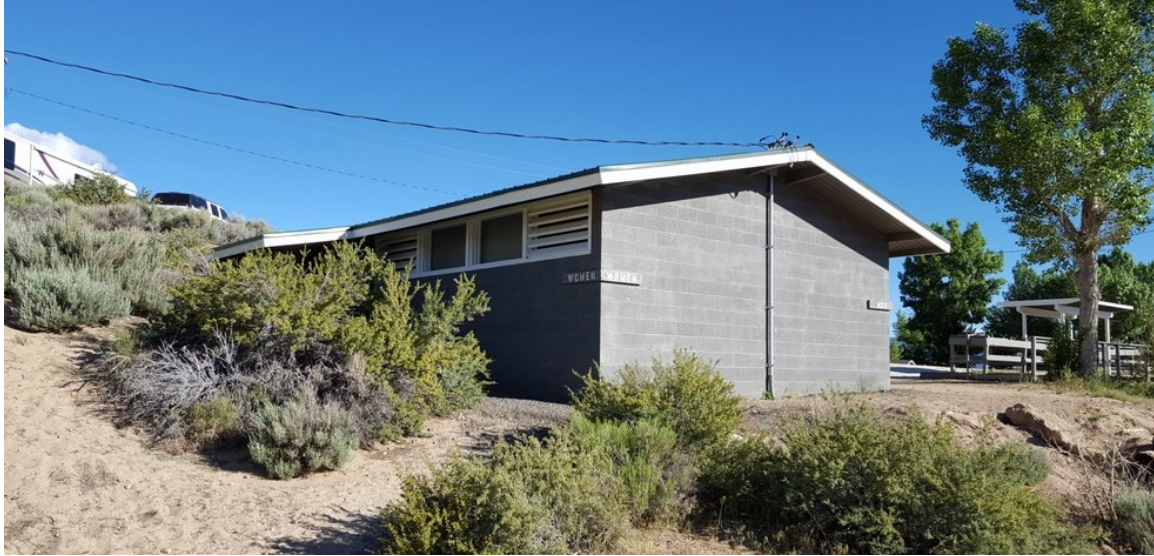
The public restroom is composed of concrete blocks, and has a shallow-pitched gable roof and both fixed windows and louvered vents. It is 36 feet long and 32 feet wide overall, and 8 feet high at its gable peak; “wings” on each side form entryways. The roof is wood-framed and covered with metal standing-seam roofing.

Figure 40. Public restroom, view toward northwest.

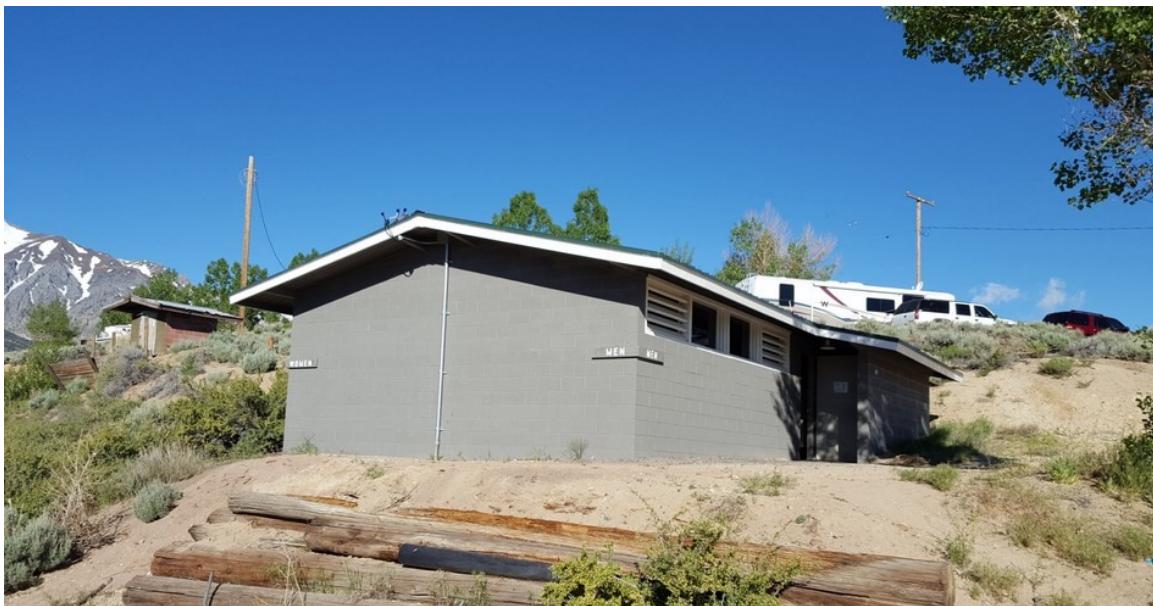
Figure 41. Public restroom, view toward southwest.

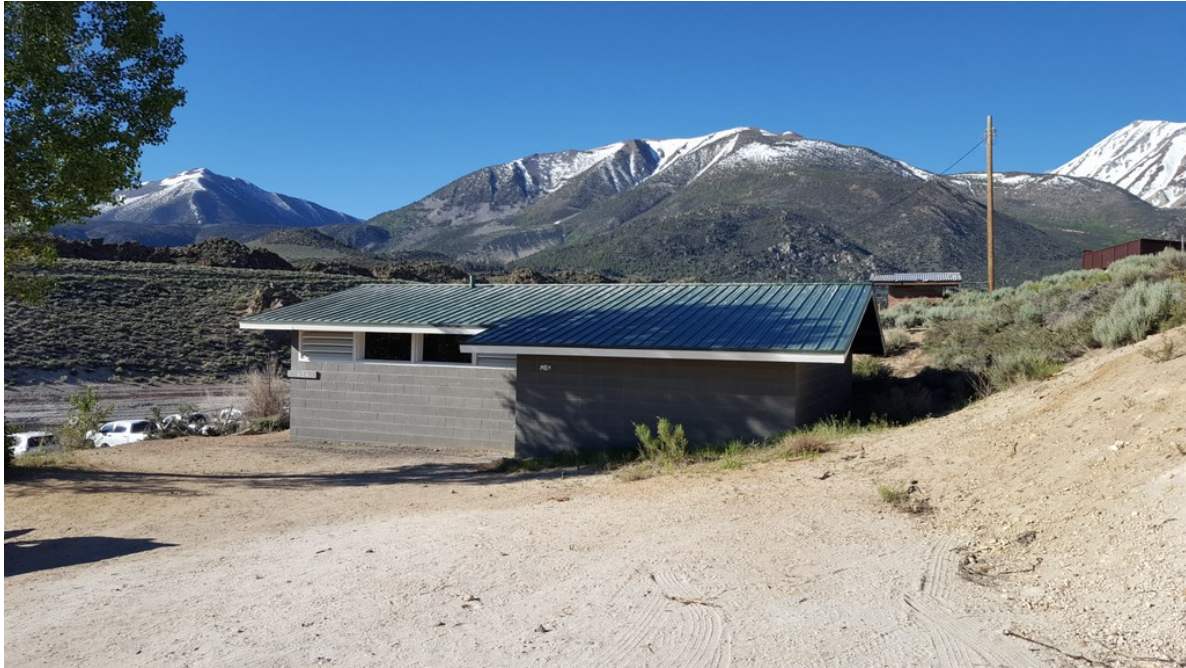
Figure 42. Public restroom, view toward south.

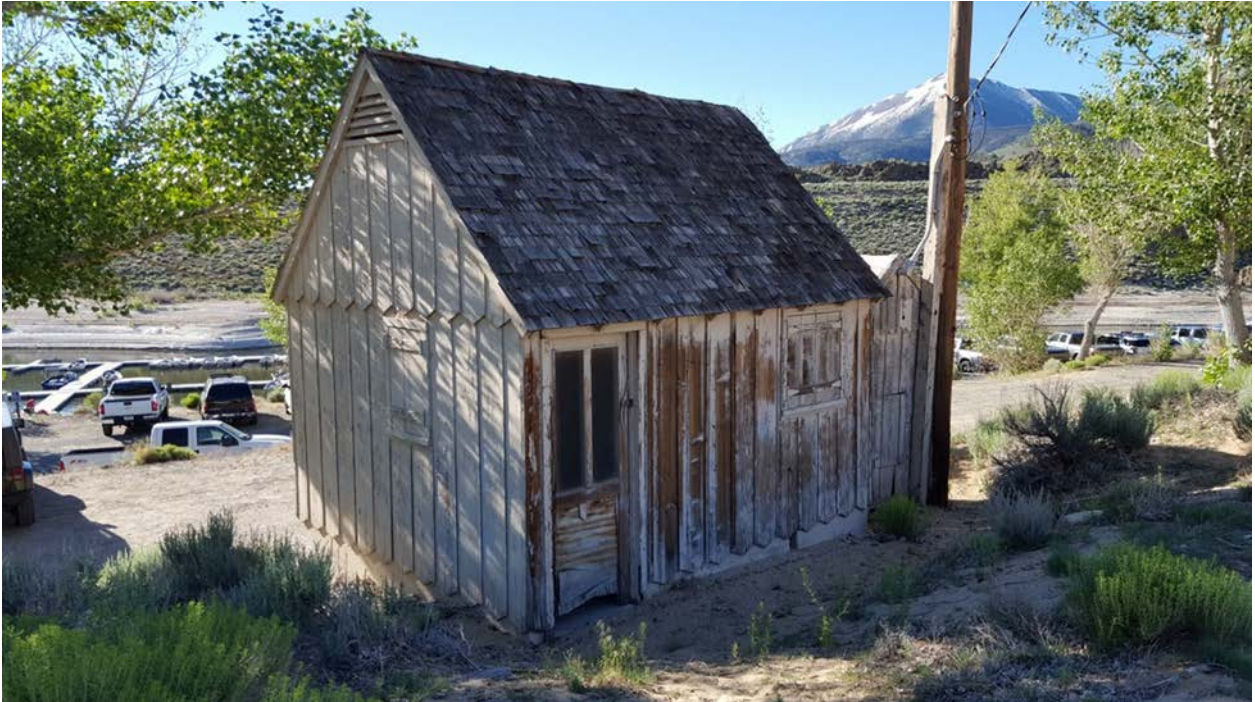
One is a small cabin, measuring about 13¼ feet by 11¼ feet, with a steep-pitched gable roof covered with wooden shingles. The cabin has vertical board-and-batten siding, with the boards 1 by 12 inches and the battens only 1½ inches by ¼ inch, more like lath or moulding than lumber. The boards are cut into V-shaped ends along the bottom above the foundation, and at the bottom of the gable ends, an unusual decorative touch on such a small building. There are triangular-shaped louvered vents at each gable peak.

There are a door and window on the front façade and windows on each end. Windows are 2-light, hopper windows (hinged at the bottom, opening inward). They have a chain to keep them from falling completely open, and a latch at the top to close. The windows have exterior operative shutters, and the door is paneled, with screen divided by a vertical mullion in the upper 3/5, and a solid (but deteriorated) wooden panel below.

Figure 43, above. LADWP cabin/shed, view to southeast. Figure 44, below right. Interior of cabin, showing scabbed ceiling joist and one of two chimney-type openings in the roof.

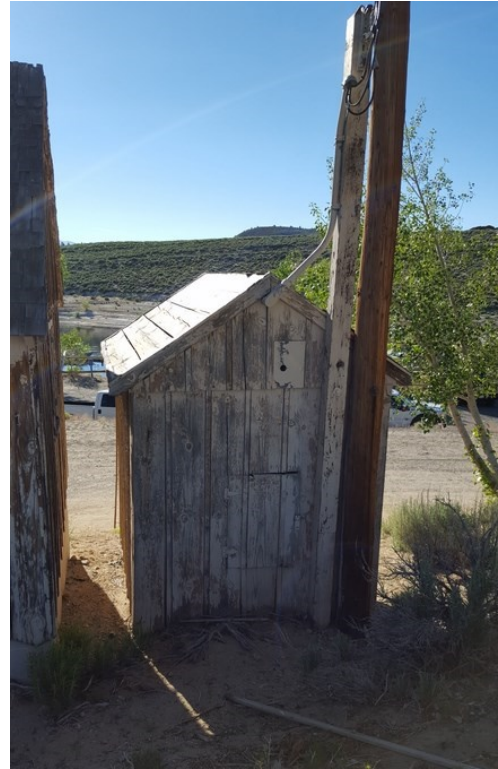
Figure 46, below. Smaller LADWP building center left, view toward northwest. Larger LADWP to right.

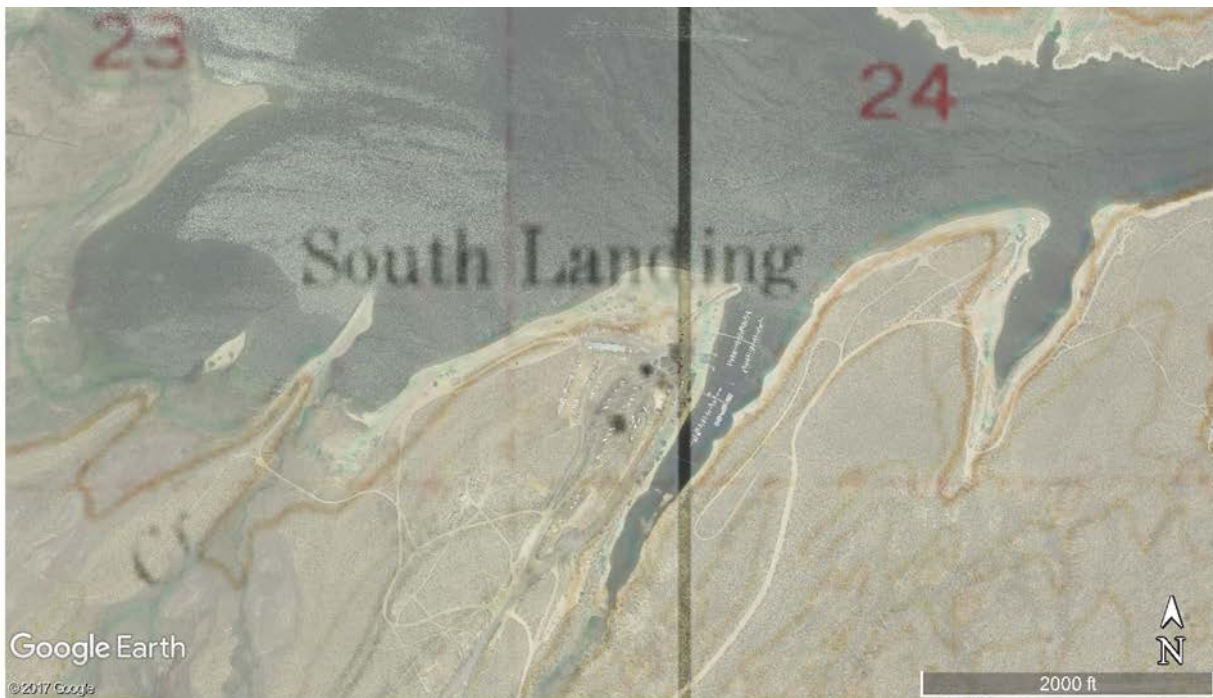
Figure 48. 1953 USGS 15-minute topographic map over the 2016 Google Earth satellite image.

However, the 1953 USGS topographic map (at 1:62,500 scale) does depict four structures within the current Crowley Lake Fish Camp, one large and three small. We can approximate how the structure locations would fit today's terrain by overlaying the topo map with the Google Earth satellite photograph and aligning features known to be present in both images. That is, once we have fit the 1953 topo over the 2016 satellite photo so that Crowley Lake dam, Whisky and Hilton Creeks, the lake shoreline, and Crowley Lake Drive (former U.S. Highway 395) match up, we can see how close the 1953 buildings are to the current structures. Results need to be interpreted somewhat liberally, to account for the different original scales of the two images, potentially different lake levels, and possible errors and distortions in the overlay. However, the 1:62,500 USGS topographic maps accurately depicted buildings where there was sufficient room on the map.

Of the four buildings on the 1953 topo map, one (the largest) is approximately at the current location of Park Model Cabin Trailers 1 and 2 (facilities #5 and #6 in Table 1 of the Mitigated Negative Declaration). One building is shown between the current locations of the managers' residence and RV-trailer spaces 3 and 4. Therefore, both of these 1953-era buildings have been removed, possibly during the Hantavirus cleanup in the early 1990s. The third building shown on the 1953 map, however, is very close to the LADWP buildings ("shed" depicted on the Mitigated Negative Declaration plan map, but not listed in Table 1). The fourth building is located close to #21, the boathouse/storage building.

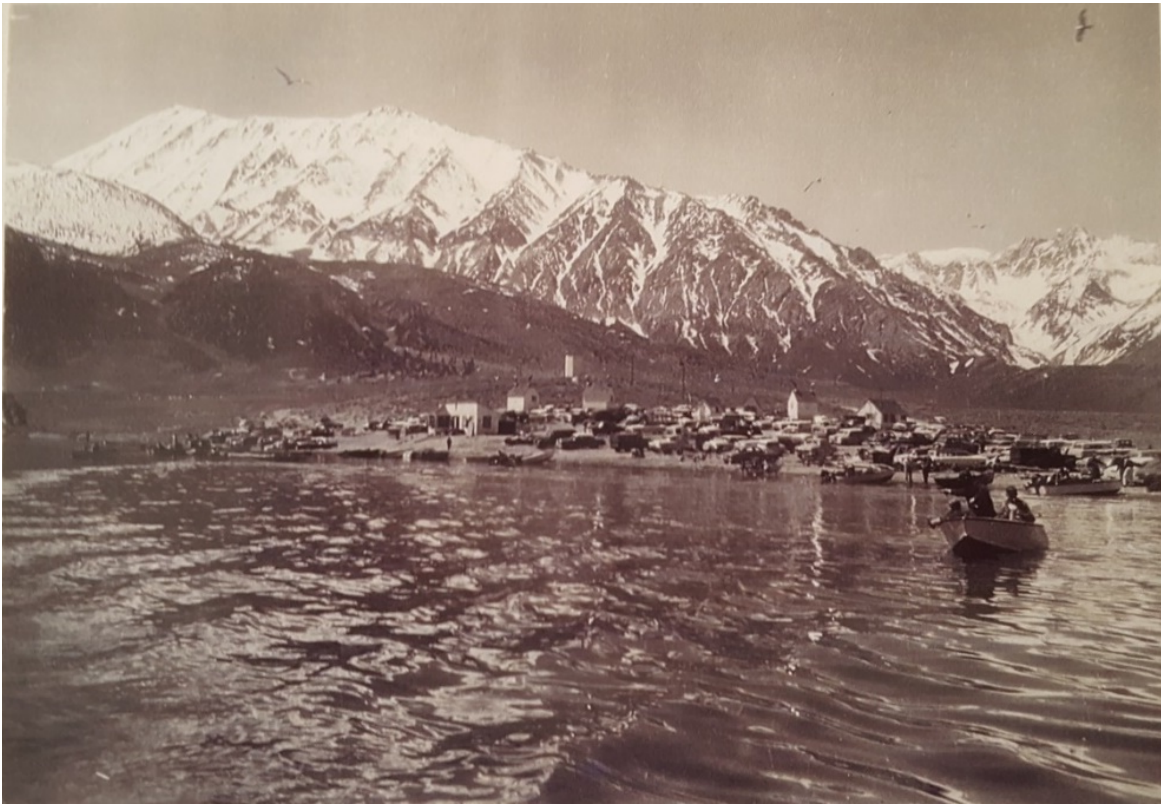
Figure 49. Historic-period photograph of Crowley Lake Fish Camp, likely dating to the 1950s.

The 1950s photograph gives us an idea of what the early Fish Camp was like, with plenty of parking and five cabins with medium- to steep-pitched gable roofs (one with a cross gable), the shed-roofed boat house, and the tall silo-type structure on the hill. No docks are visible, but some boats appear to be launching directly from the shore. The photograph also shows one structure very close to the location of the current boathouse/storage building. However, that building does not match the current structure: the main part of the building in the photo has a shed roof, rather than a gable or cross-gable roof. A small gable-roof extension extends from the southern part of the building, but that extension does not appear to be equivalent to either part of the current boathouse.

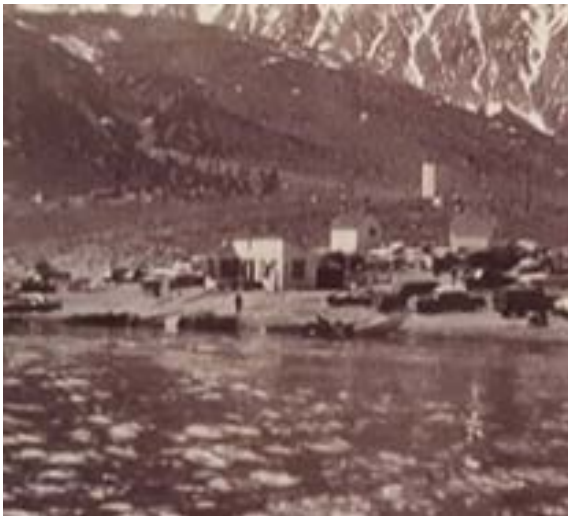
Figure 51. Detail of Figure 60, shed-roofed boathouse near center of frame, one LADWP cabin immediately to right.

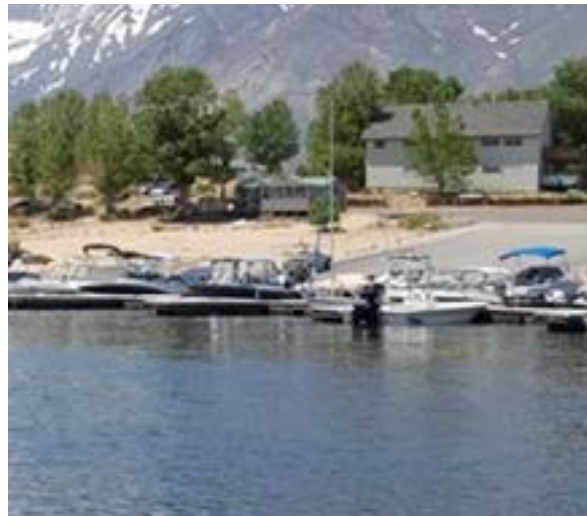
Figure 52. Detail of Figure 61, cross-gable-roofed boathouse near center of frame.

In the second historic photo, there are not many vehicles to suggest a date, but the vegetation has matured and the photo is in color, suggesting it was taken later, likely sometime in the 1970s. There is a building at the boathouse/storage building location with window spacing similar to that in the current boathouse, but the 1970s building is the same shape as the shed-roofed structure in the earlier photo. In addition, the 1970s building can be distinguished from the current structure by the location of the windows, which are lower in the façade facing Whisky Bay.
